Re: 2013 Annual Report
RIPDES Permit NO. RIR040012, Cranston, RI

RIPDES SMALL MS4 ANNUAL REPORT

NO-PCB MODF RELEASE
POLE NO. 2-50, ADJACENT TO
24 MIDWAY DRIVE
CRANSTON, RHODE ISLAND

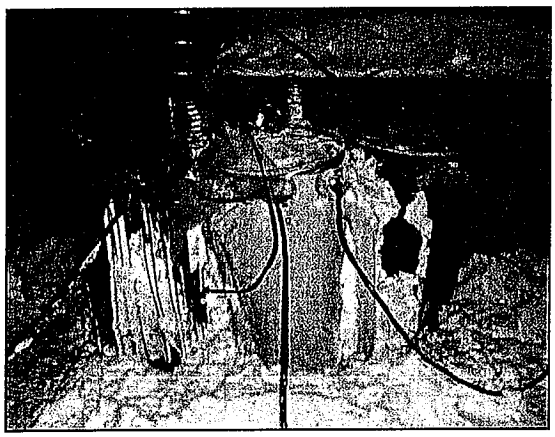
Photo 1
Location of the 50 kVA electrical transformers associated with the damaged three-phase electrical transformer bank formerly atop utility Pole No. 2-50 on February 10, 2013, as viewed from the northeast.

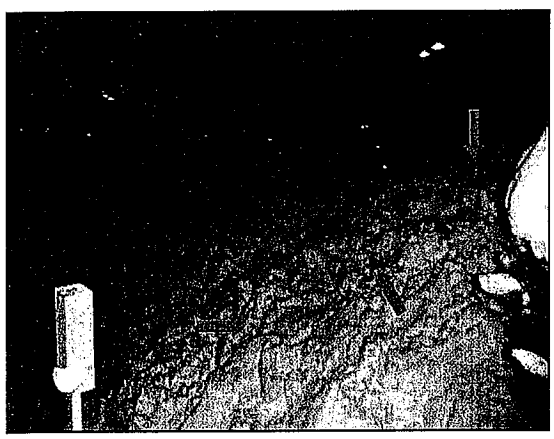
Photo 3
Location of snow pile in which no-PCB MODF-impacted snow located in the initial release area was plowed prior to additional response actions on February 10, 2013, as viewed from the north. Note the no-PCB MODF staining throughout the snow pile.

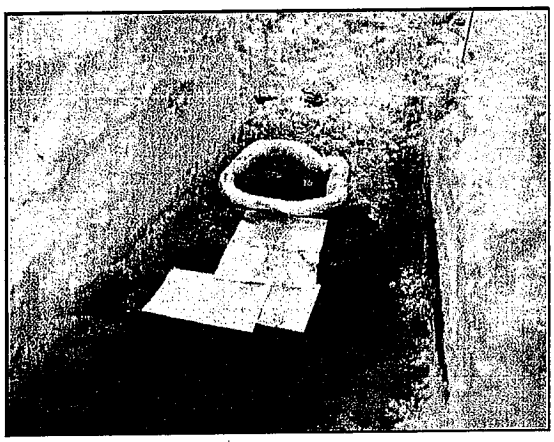
Photo 9
Location of newly uncovered stormwater catch basin CB-01 on February 11, 2013, located approximately 365 feet southeast of the initial release area, as viewed from the southwest.

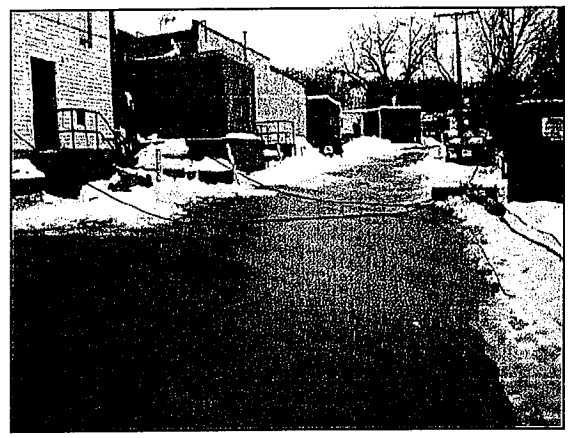
Photo 10
Site conditions in the initial release area at the completion of additional response actions on February 11, 2013, as viewed from the southeast.

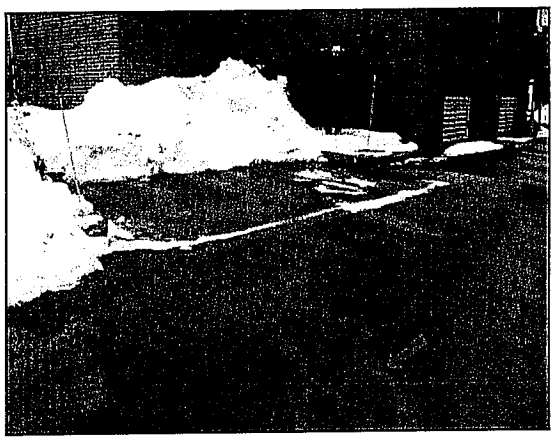
Photo 13
Site conditions prior to additional snow removal activities on February 12, 2013, as viewed from the southeast. Note the sheen from the snow melt along the asphalt pavement.

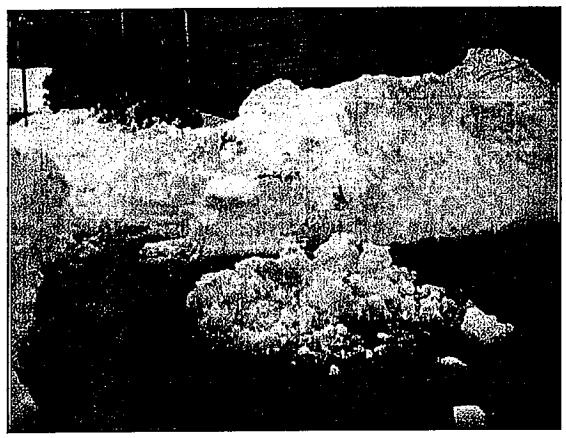
Photo 14
Site conditions during additional snow removal on February 12, 2013, as viewed from the east.

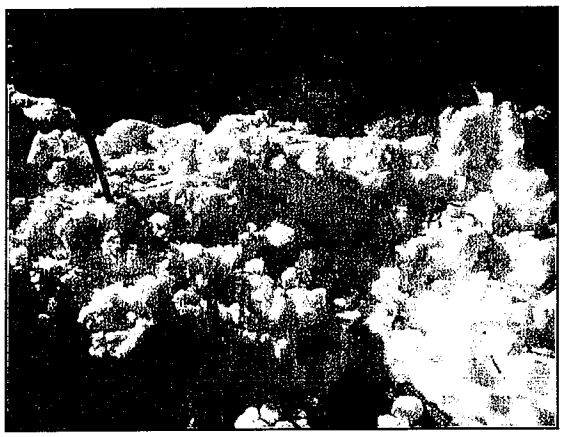
Photo 18
Site conditions following additional snow removal activities on February 12, 2013, as viewed from the north.

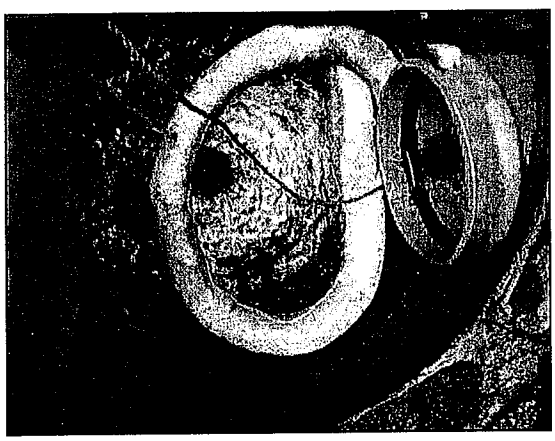
Photo 19
Interior of impacted stormwater catch basin CB-02, located along Midway Road, following response actions on February 12, 2013.

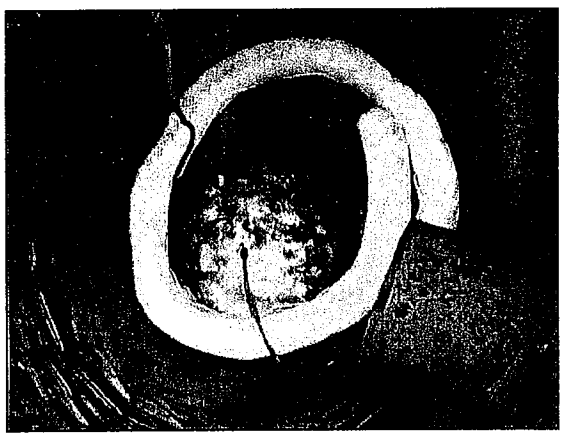
Photo 20
Interior of impacted stormwater catch basin CB-02, located along Garden Court, following response actions on February 12, 2013.
